Re: Measuring Device Notice No. SEAA 1089

On November 23, 2004, I conducted a site visit of the Utah Lake Distributing Company's measurement structures with Fred Larson of Metropolitan Water. There is an 8-ft Parshall flume on the Riverton (North) branch just before it enters the tunnel. The stilling well is equipped with a Milltronics MultiRanger Plus, which gives a digital readout at both the site and at the Metropolitan Water pumping station. The Saratoga (South) branch has an identical flow measurement setup, except the Parshall flume is 4-ft, instead of 8-ft.

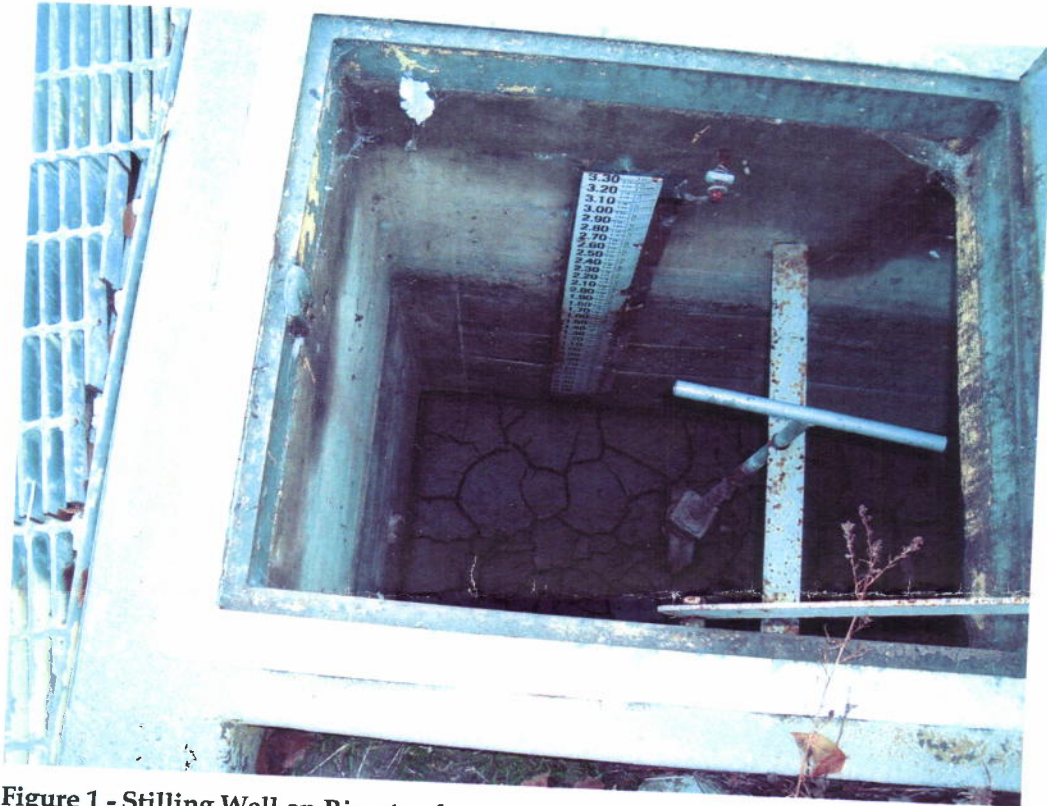
I have included some pictures of the structures on the next pages. The Saratoga flume is shown, but I have not included a picture of the Riverton flume as it is under a metal grate. Both flumes appear in good condition. The stilling well of the flume on the Riverton branch has some mud in it, but it is below the level of the flume's floor and will be cleaned out before the new irrigation season.

Figure 1 - Stilling Well on Riverton branch of ULDC canal

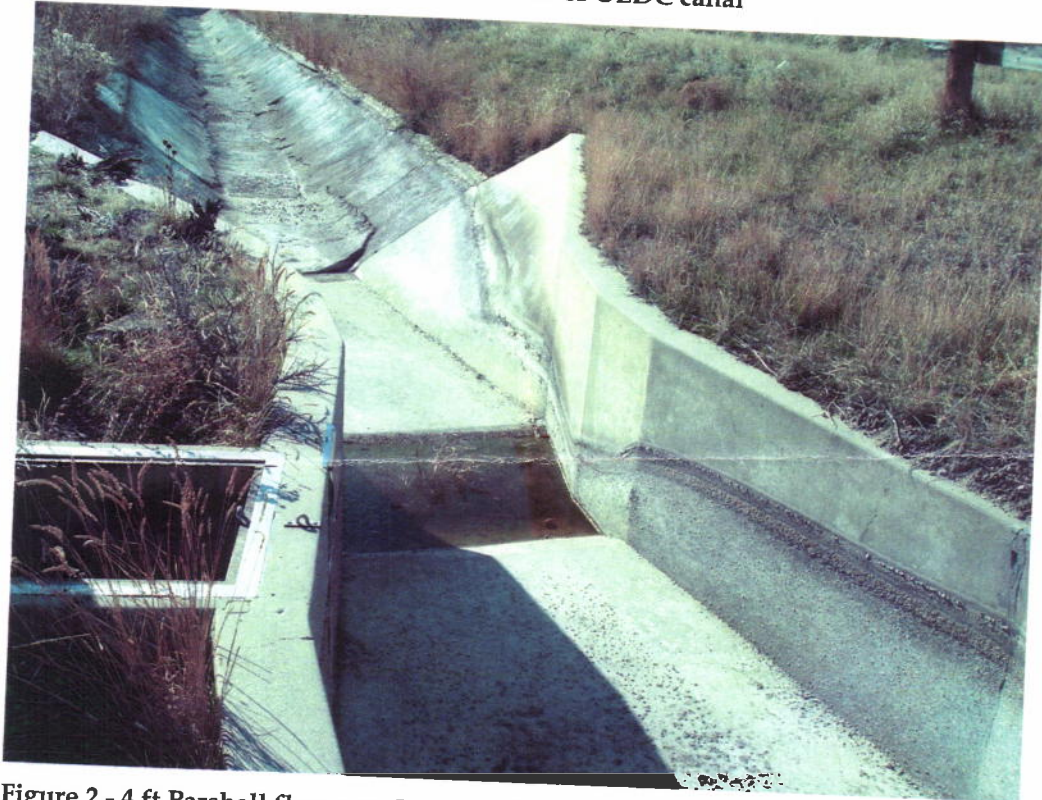
Figure 2 - 4 ft Parshall flume on Saratoga District of ULDC canal

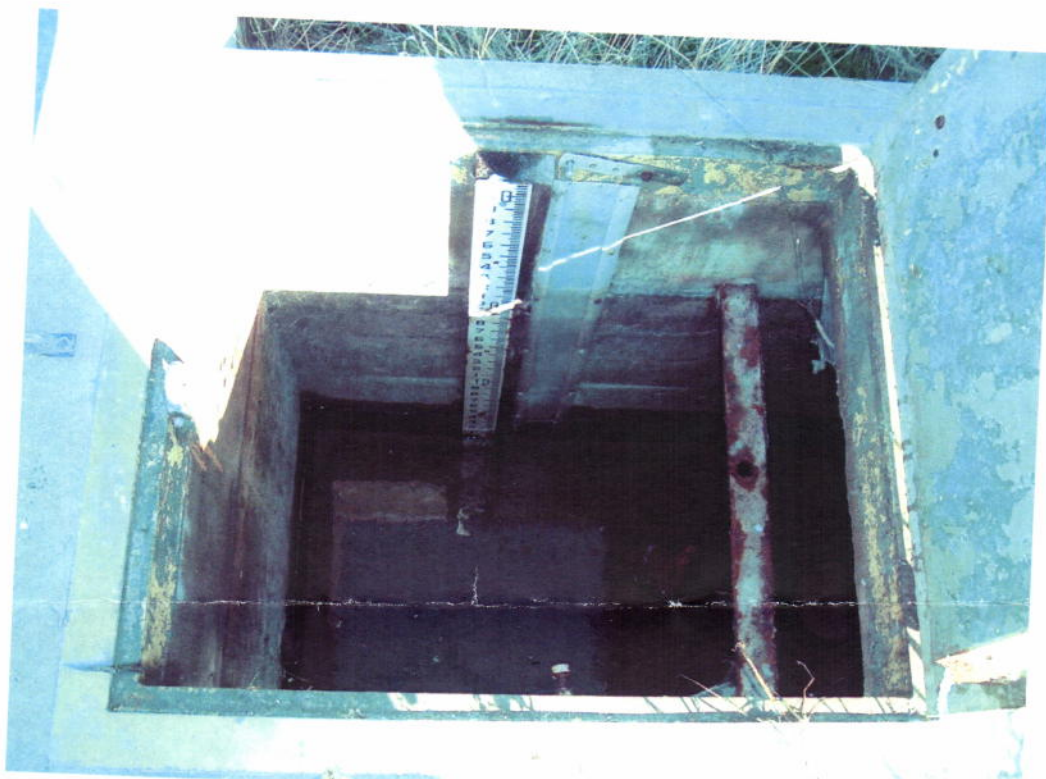
Figure 3 - Stilling well on Saratoga district of ULDC canal
